# Your Building Inspection Report

CONFIDENTIAL REPORT FOR  
Liston Dsouza  
ID 139463  
Wednesday, November 20, 2024

Les Downes has completed an assessment of **192B Tramway Rd Enderley Hamilton 3214** on the **20/11/2024** and recorded any potential site hazards. Any Hazards marked as **RED** are of potential concern and may have resulted in the incompleteness of the report due to Health & Safety Concerns. Additional details relating to the Hazard can be found in the link next to the Hazard. It is our recommendation these Hazards are addressed where applicable.

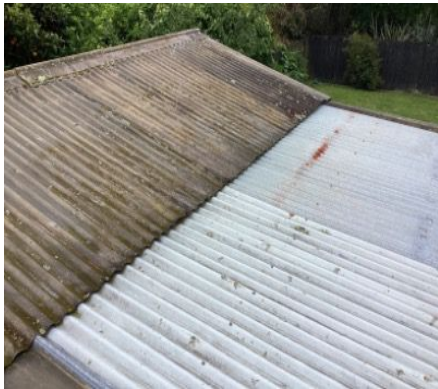
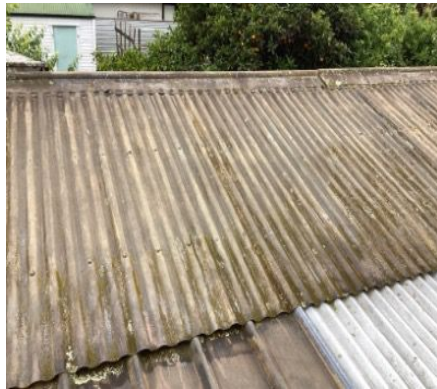
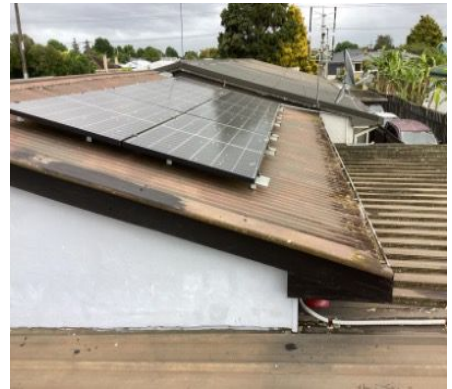
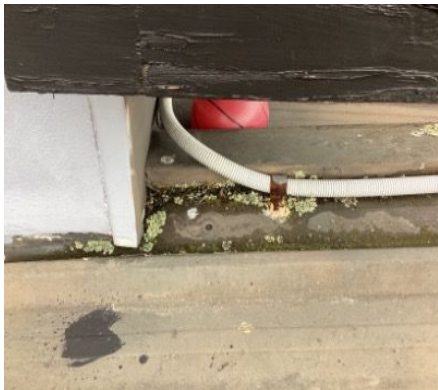
This roof is nearing the end of its economic life. This may affect the water tightness of the roof. We recommend a roofing contractor conduct further investigation.

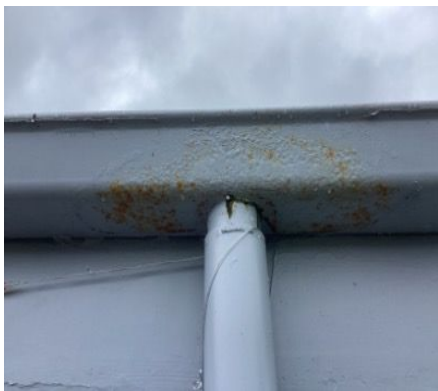
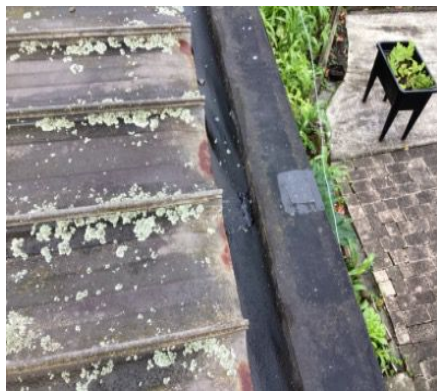
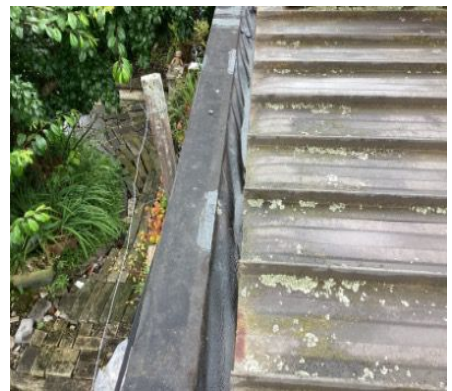
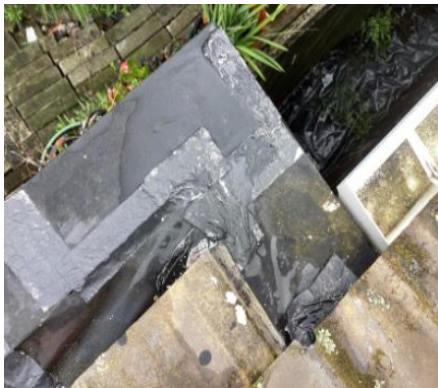
Membrane roof coatings such as the one on this dwelling have the potential to allow water entry through poor application and installation, lack of maintenance, poor detailing and complex junctions. We suggest that a thorough examination is completed bi-annually (ideally at the end of winter and end of summer), and any bubbling, water pooling, lifting of membrane or any signs of deterioration of the membrane should be investigated by a membrane roofing specialist.

On the balance of probability it is likely that this roof coating will leak if it is not detailed more effectively. We recommend this roof be further investigated by a roofing specialist. We recommend the membrane be investigated by a membrane roofing specialist. The gutter is corroded in areas. This will lead to the inadequate discharge of rainwater. We recommend a roofing contractor conduct further investigation. Allow to constantly monitor and maintain as required.

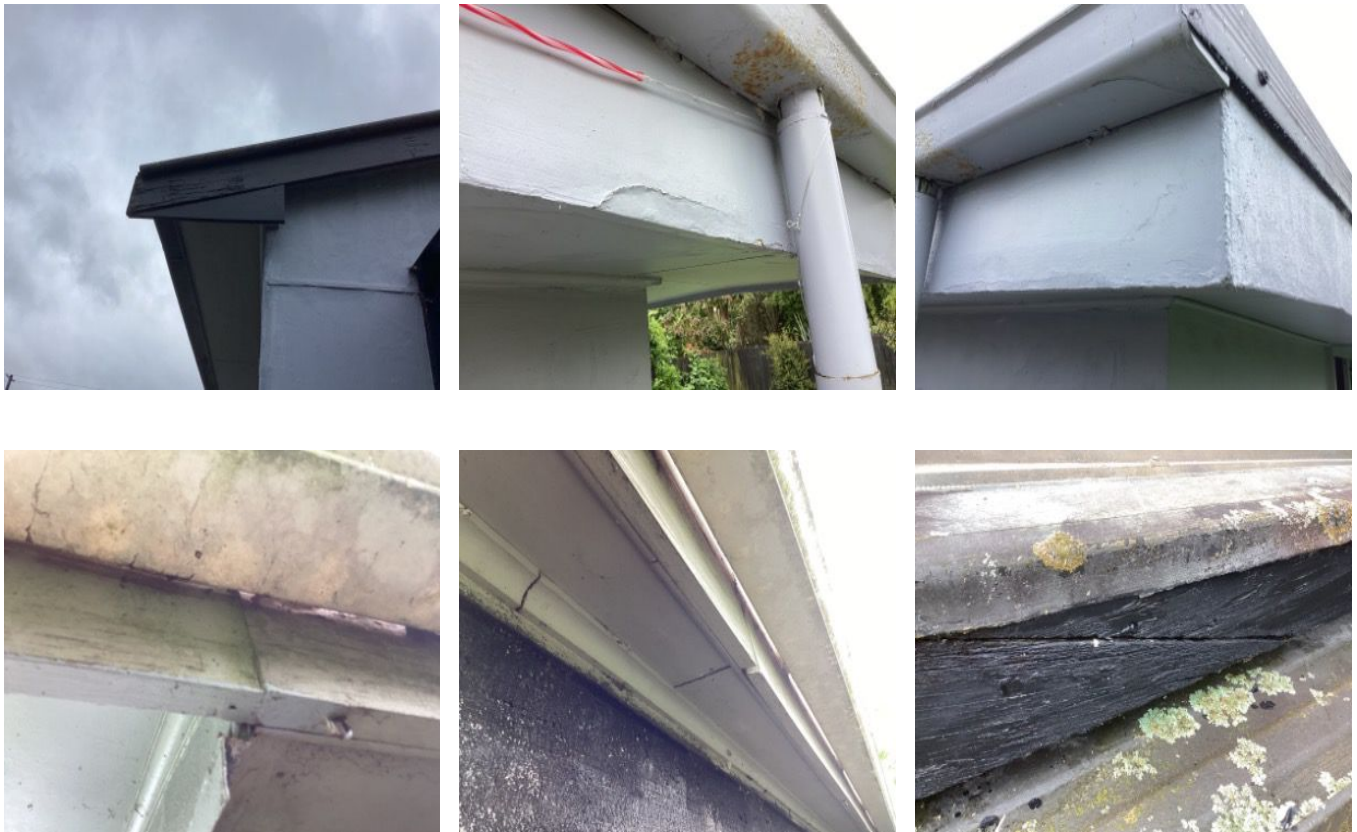
Wet rot decay is present in timber fascia. The fascia is damaged. We recommend this is replaced. Some of the soffits are cracked.

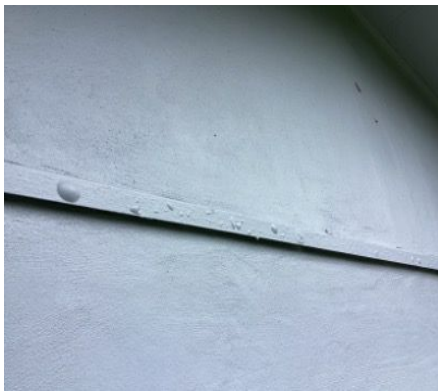
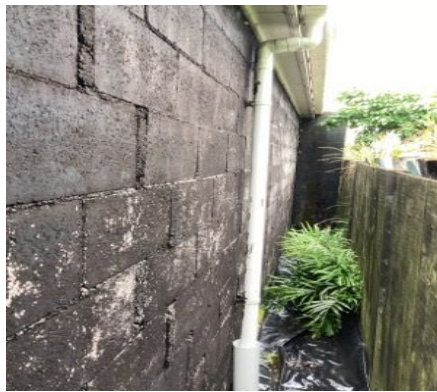
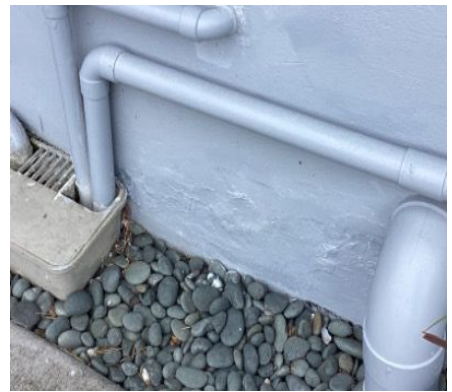
Plastered render over a backing substrate relies on a coating to resist the penetration of moisture. This system is therefore of high concern. Systems such as the one on this dwelling have the potential to allow water entry and deterioration through poor application and installation, lack of maintenance, poor detailing and complexity. Plastered systems similar to the cladding on this dwelling can allow water entry through cracks and complex junctions. From our visual inspection, the cladding appears to be performing; however, we recommend the cladding should be inspected semi-annually (ideally at the end of winter and end of summer) - any cracking or deterioration of the cladding should be investigated by a suitably qualified cladding specialist.

Ground level & floor level close.

There is a small amount movement cracking evident. This may affect the integrity of the cladding. We recommend further investigation.

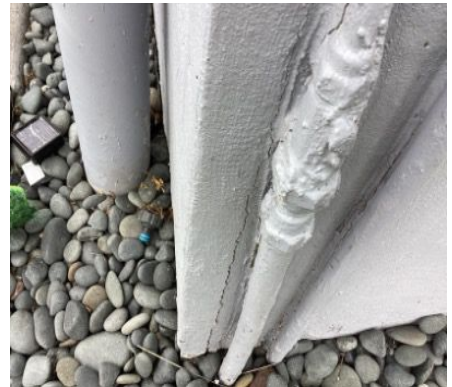
Blocks not sealed correctly.  
Recommend to repair and seal.

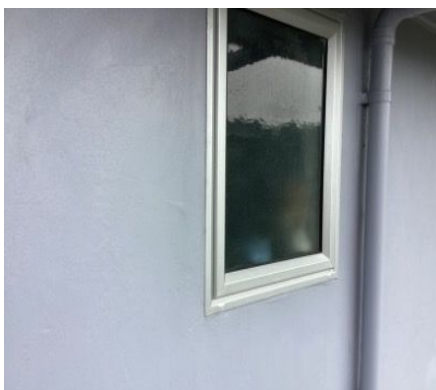
Joinery set in a plastered cladding on a coating to resist the penetration of moisture between the two materials. This system is therefore of high concern. Systems such as the one on this dwelling have the potential to allow water entry and deterioration through cracking, poor application and installation, lack of maintenance, poor detailing and complexity. This tends to occur particularly on buildings built between 1980 and 2006. On the balance of probability it is likely that this junction will leak if it is not detailed more effectively. We recommend this junction be further investigated by a weather tightness specialist. No visible issues were noted during the inspection. Allow to constantly monitor and maintain as required.

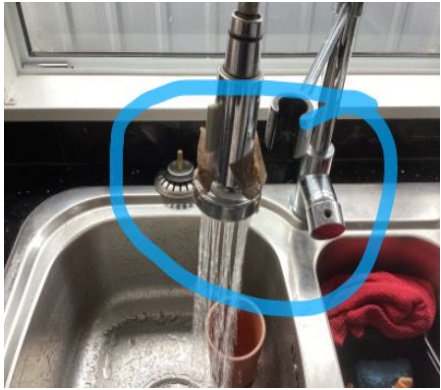
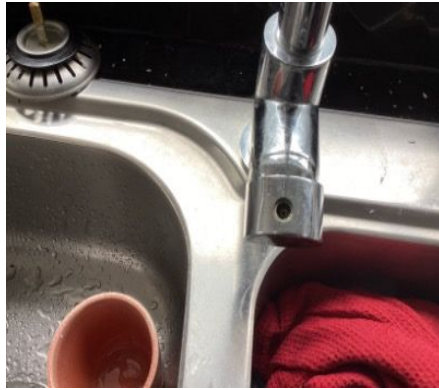
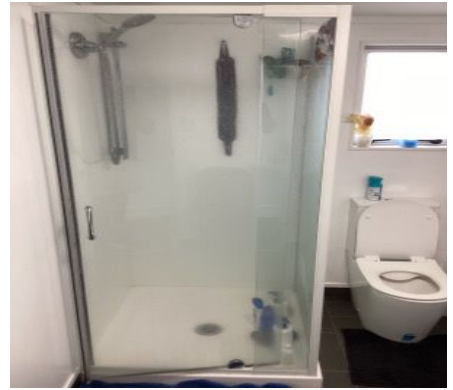
The kitchen tap is damaged. We recommend repair. There's no laundry tub.  
The vanity is functioning as intended. The kitchen sink is functioning as intended. The laundry tub is functioning as intended.

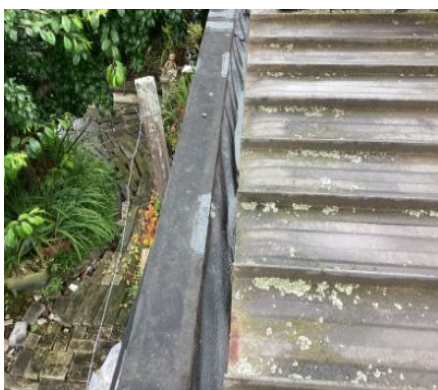
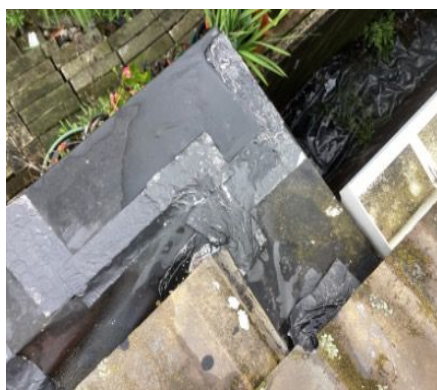
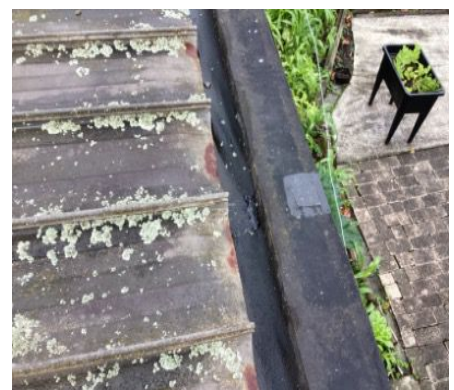
There are internal gutters installed. The membrane gutter coatings such as the one on this dwelling have the potential to allow water entry through poor application and installation, lack of maintenance, poor detailing and complex junctions. This tends to occur particularly on buildings built between 1990 and 2006. We suggest that a thorough examination is completed bi-annually (ideally at the end of winter and end of summer), and any bubbling, water pooling, lifting of membrane or any signs of deterioration of the membrane should be investigated by a membrane roofing specialist. We recommend the membrane be investigated by a membrane roofing specialist.

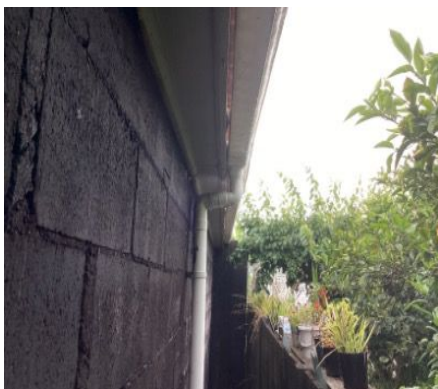
There are no soffits in areas. There are narrow soffits in areas.

Due to the narrow soffits the cladding and flashings around all windows, doors and penetrations are relied on more heavily to keep water from penetrating the building envelope. We suggest that a thorough examination is completed bi-annually (ideally at the end of winter and end of summer), and any deterioration in the cladding or flashings are investigated by a weather tightness specialist. Due to the lack of soffits above areas of the cladding and flashings around all windows, doors and penetrations are relied on more heavily to keep water from penetrating the building envelope. We suggest that a thorough examination is completed bi-annually (ideally at the end of winter and end of summer), and any deterioration in the cladding or flashings are investigated by a weather tightness specialist. Conventional pitched roof shapes extend beyond external wall lines. This traditional design feature effectively shelters the top of the wall cladding and window heads that are close to the soffit. This reduces the risk external moisture ingress.

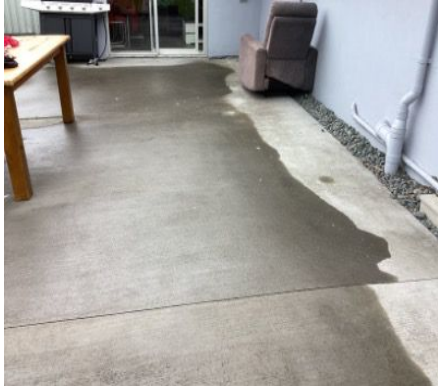
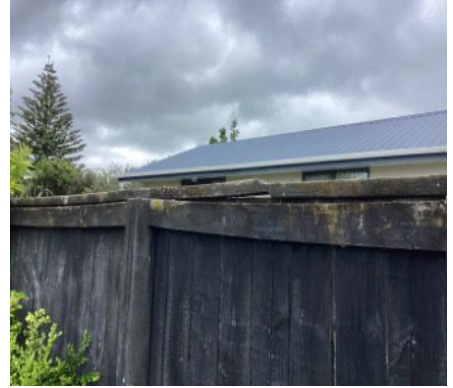
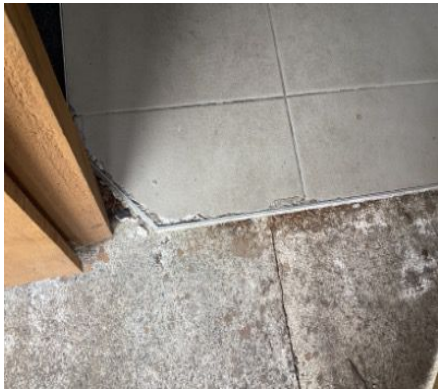
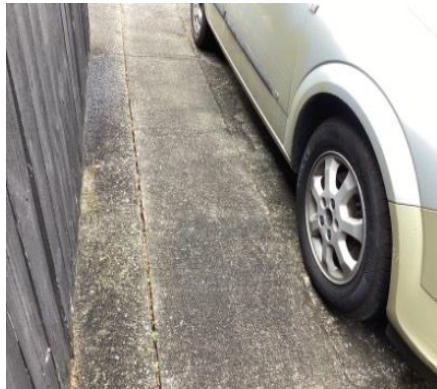
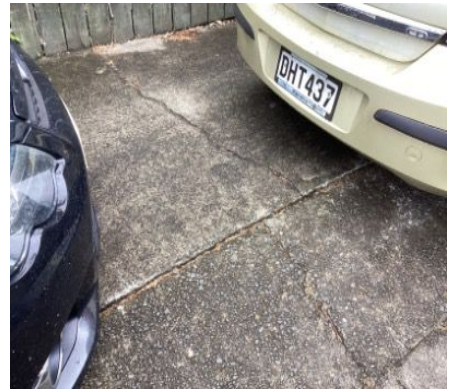
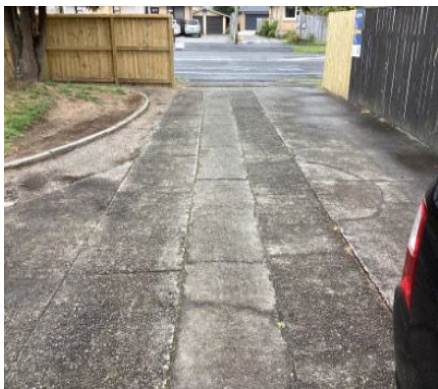
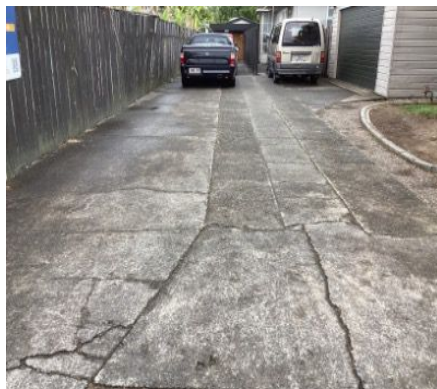
Part of the driveway is shared; we recommend you further investigate with your lawyer's assistance what obligations you have in regard to repairs and maintenance of the shared driveway. The surface of the driveway requires repair. There is subsidence to the driveway. Allow to constantly monitor and maintain as required.

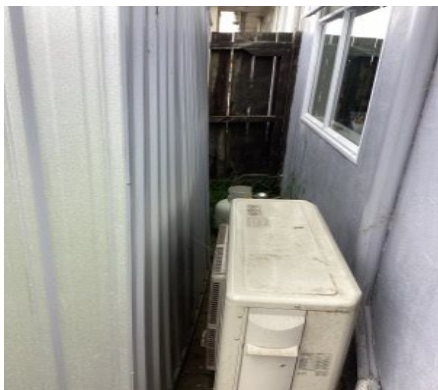
There is minor decay/weathering to the outbuilding structure.

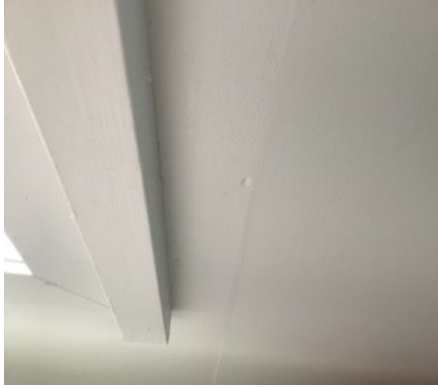
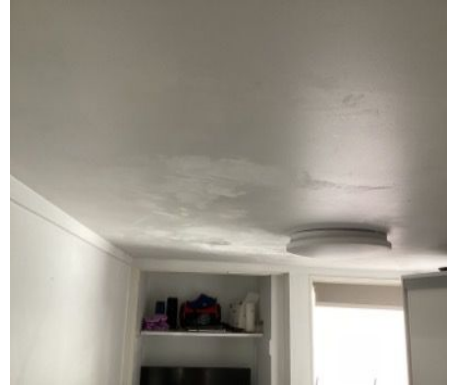
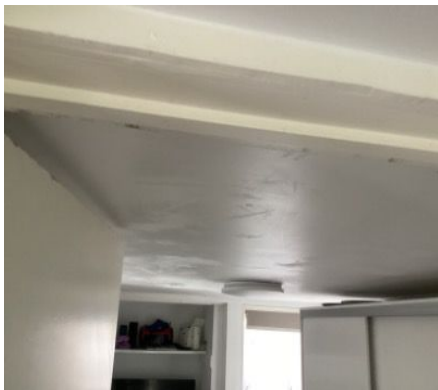
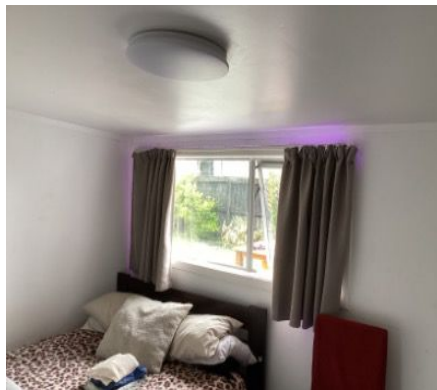
The ceiling linings have minor imperfections. These appear to be aesthetic. The ceiling height is low. There are nails "popping" in areas. We recommend these are repaired when the affected area is next redecorated.

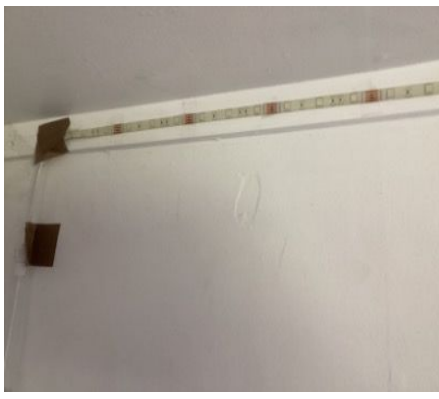
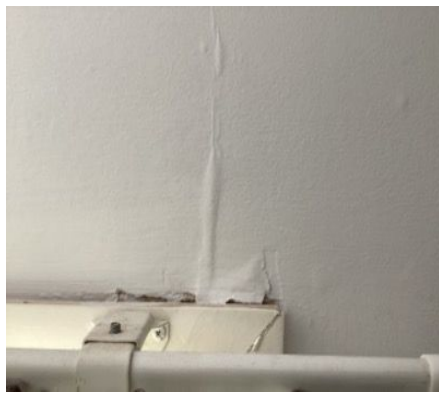
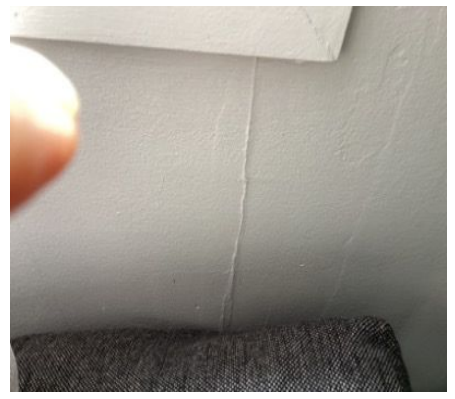
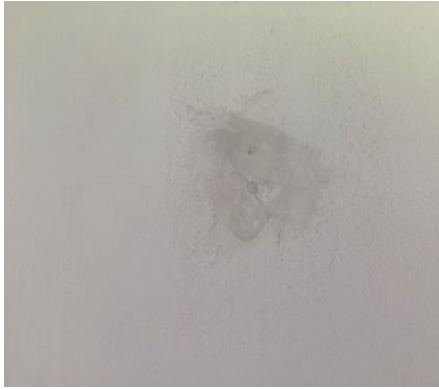
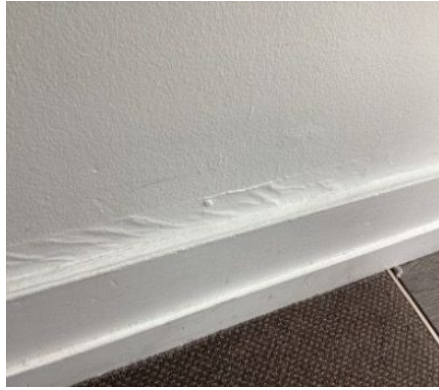
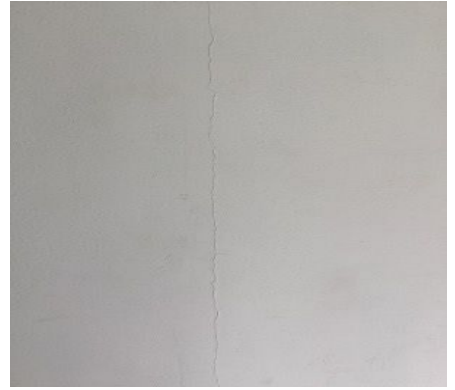
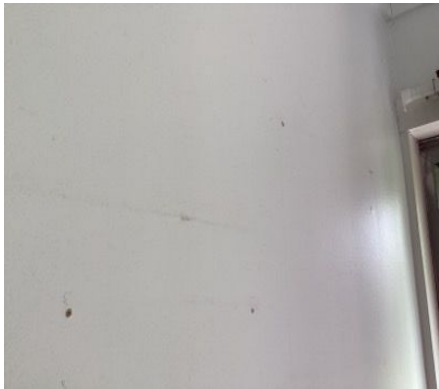
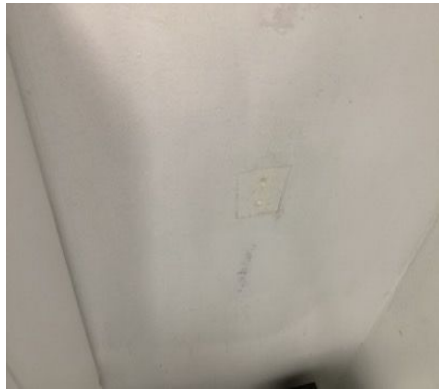
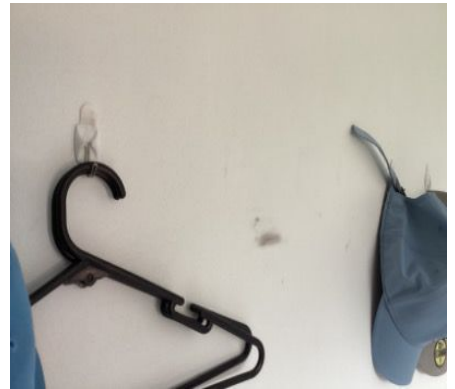
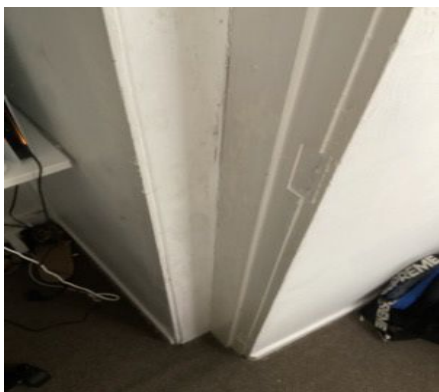
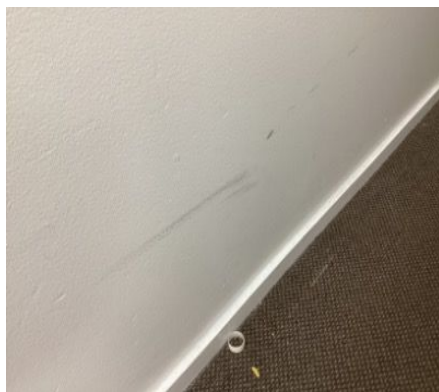
There is bubbling or blistering to the paint covering of the linings. We recommend that this is further investigated. The paint on some linings is in poor condition. There are scratches and marks to the internal linings. There are some small holes in the interior linings. This detracts from the aesthetics of the property. The wall linings have minor imperfections. The wall linings have cracked. These appear to be aesthetic. Allow to constantly monitor and maintain as required.

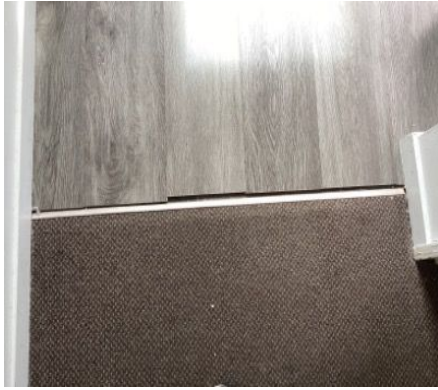
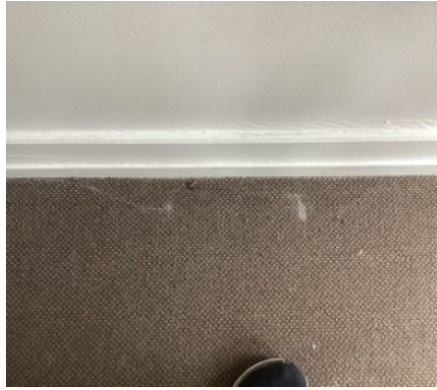
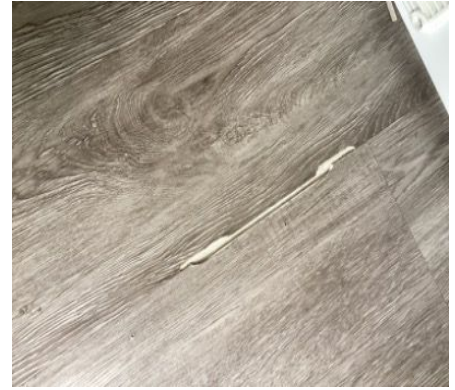
The floor covering is stained in areas. The finished floor level of the ground is similar as the finished floor level of the interior room. We recommend a channel drain be installed in this area.

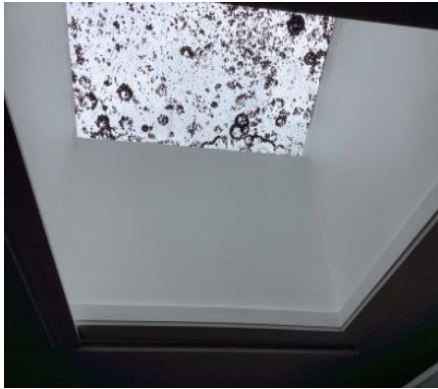
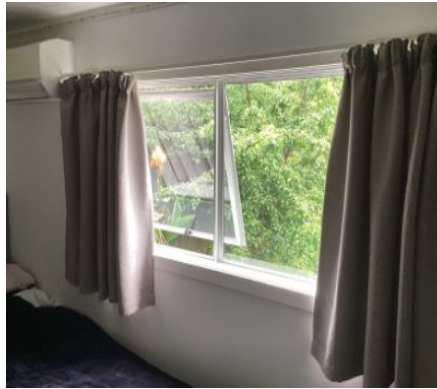
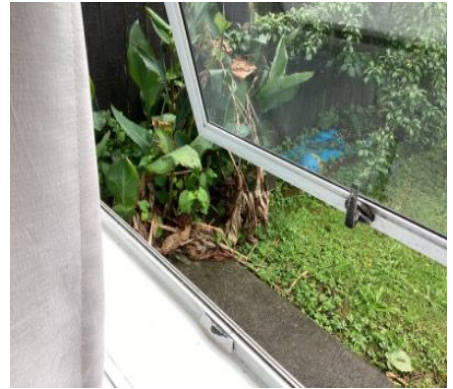
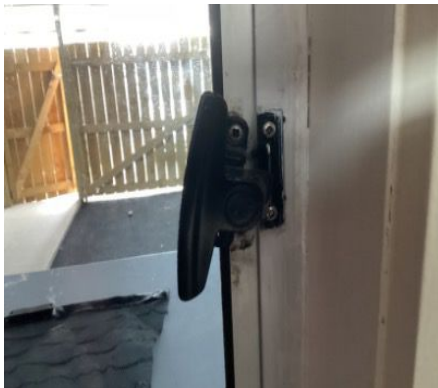
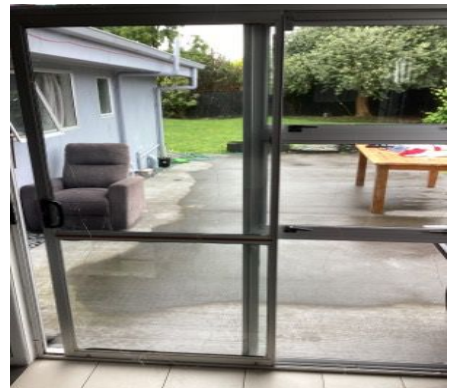
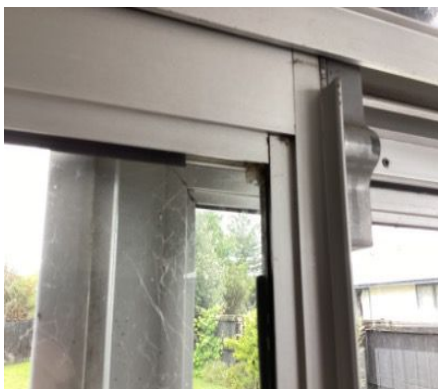
There is skylights located in the ceiling. Skylights are high maintenance windows that are very hard to flash on the roof side and are prone to leaking. Allow to monitor the surrounding ceiling linings. If the paint begins to bubble, blister or peel call a qualified builder as these are tell tail signs of leaking. Some maintenance is required to joinery hardware. Weathered glazing beads beginning to shrink which may allow water ingress. We recommend further investigation.

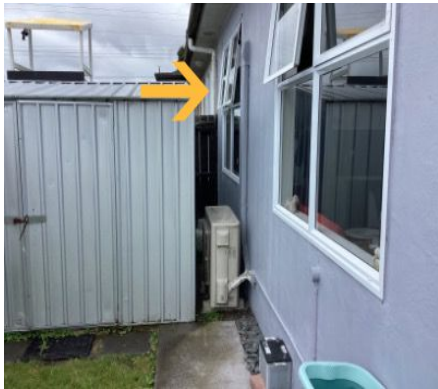
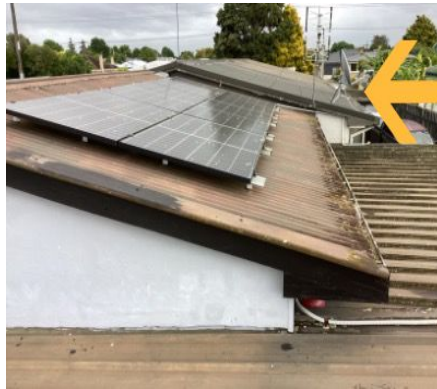
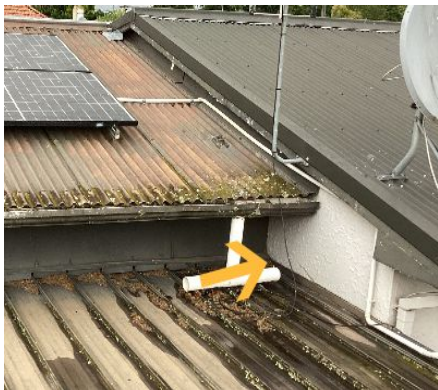
We recommend that you follow up on any advice given and check out the council Lim report. We recommend this dwelling is further investigated by the appropriate trades people to quote for the work required prior to confirming the purchase. The house is adjoining the house next door, please check council records for details and sign off for fire wall.
