GFORCE
WEINSTALL

Healthy Homes Report for
73 MORROW AVE, ST ANDREWS

Address of Property 73 MORROW AVE, ST ANDREWS
Client Name Waikato Real Estate

Assessment Date 27/06/2024
Assessors Name Jonah Poloa

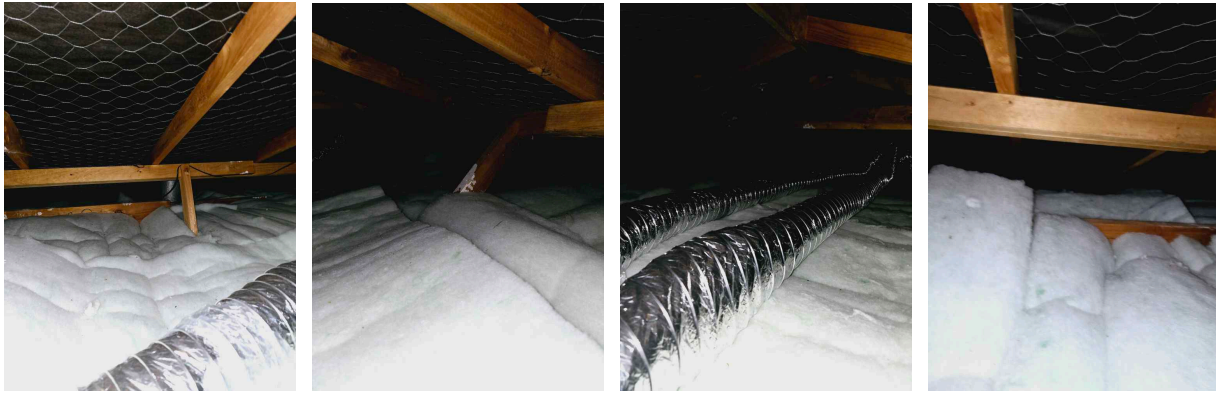
Ceiling Insulation Photos

Existing Insulation	GreenStuf
Existing R-Rating (if known)	R2.9
Existing Thickness	170mm
Overall Insulation Condition	Good
Install Date (if known)	---

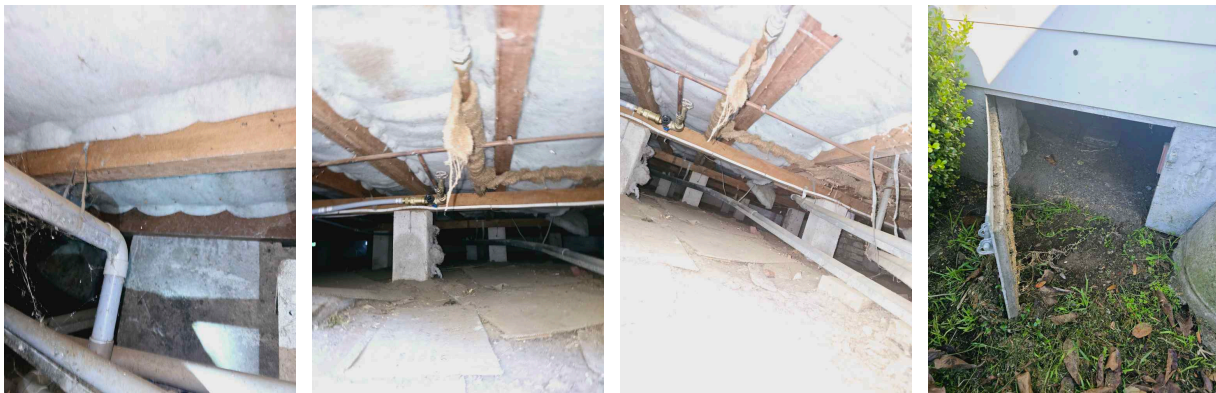
Underfloor Insulation Photos

Existing Insulation Type	Polyester
Existing Depth or R-Rating	R1.5
Overall Insulation Condition	Good
Install Date (if known)	---

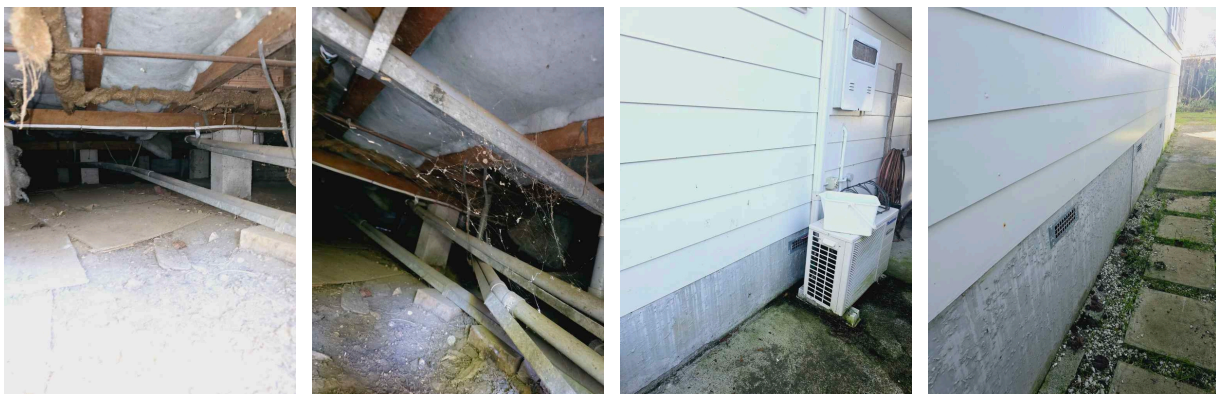
On-Ground Vapour Barrier Photos

No O-Gvb Installed
Workspace Insufficient
Over 50% Obstructed

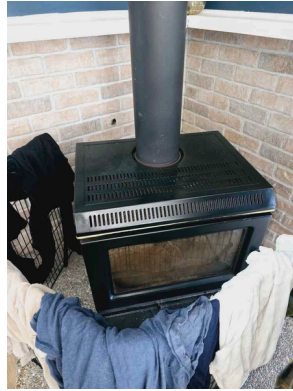
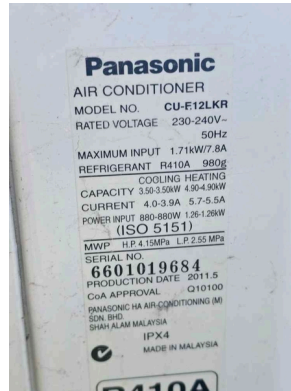
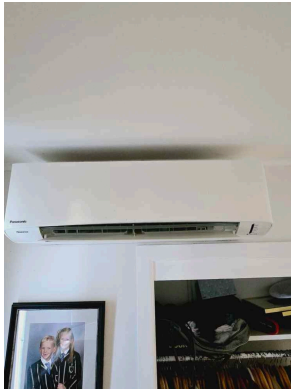
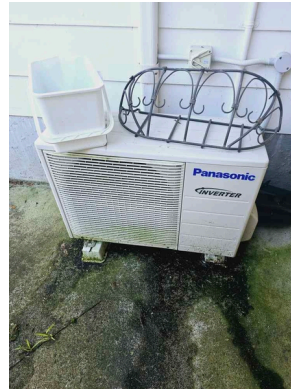
Heating Photos

Fireplace
16.00kW
Yes
Unknown

The living area is equipped with a heat pump and a woodburner, while the main bedroom has an additional heat pump.

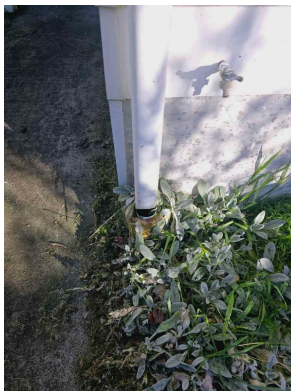
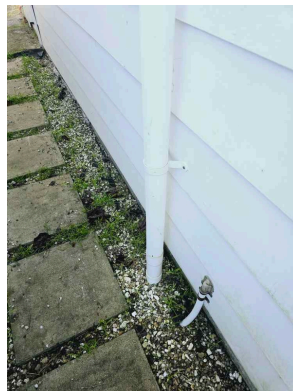
Drainage Photos

Clear and Flowing
Clear and Flowing
No Evidence of Issues

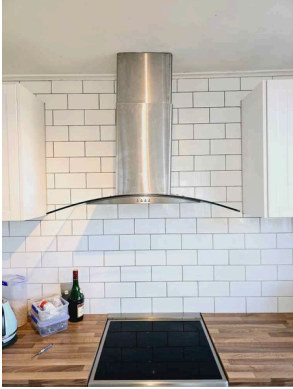
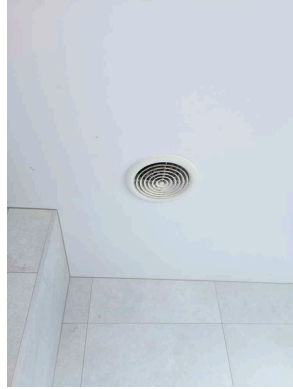
Extraction Fan Photos

Ventilation Present	Rangehood	---->	Solution:
Fan Condition	Fully Functional	---->	Solution:
Ducting Status	≥150mm or 50L/s	---->	Solution:
Installed Date	Unknown

Ventilation Present	Ceiling Fan	---->	Solution:
Fan Condition	Fully Functional	---->	Solution:
Ducting Status	≥120mm or 25L/s	---->	Solution:
Installed Date	Unknown
