# Your Building Inspection Report

CONFIDENTIAL REPORT FOR  
Liston Dsouza  
ID 139463  
Wednesday, November 20, 2024

Les Downes has completed an assessment of **192B Tramway Rd Enderley Hamilton 3214** on the **20/11/2024** and recorded any potential site hazards. Any Hazards marked as **RED** are of potential concern and may have resulted in the incompleteness of the report due to Health & Safety Concerns. Additional details relating to the Hazard can be found in the link next to the Hazard. It is our recommendation these Hazards are addressed where applicable.

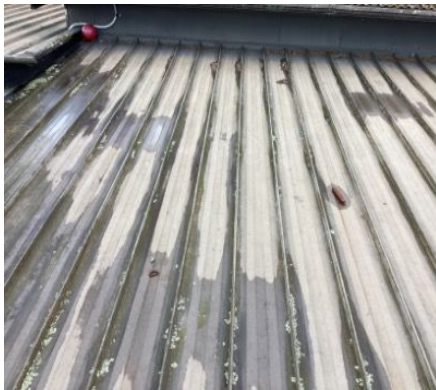
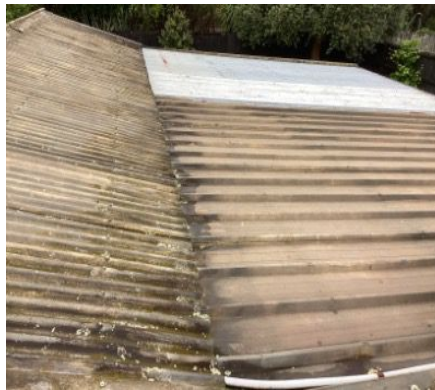
This roof is nearing the end of its economic life. This may affect the water tightness of the roof. We recommend a roofing contractor conduct further investigation.

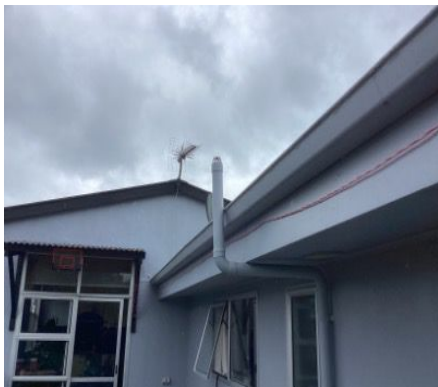
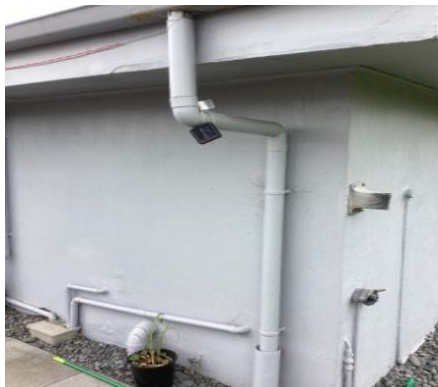
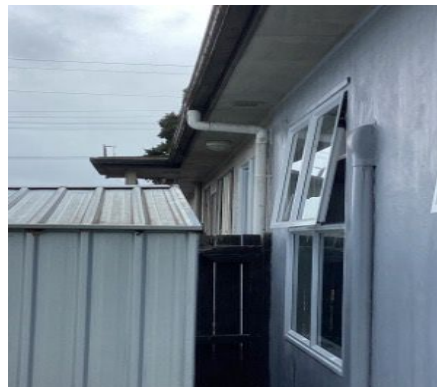
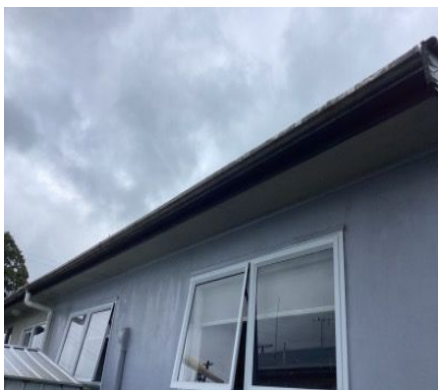
Membrane roof coatings such as the one on this dwelling have the potential to allow water entry through poor application and installation, lack of maintenance, poor detailing and complex junctions. We suggest that a thorough examination is completed bi-annually (ideally at the end of winter and end of summer), and any bubbling, water pooling, lifting of membrane or any signs of deterioration of the membrane should be investigated by a membrane roofing specialist.

On the balance of probability it is likely that this roof coating will leak if it is not detailed more effectively. We recommend this roof be further investigated by a roofing specialist. We recommend the membrane be investigated by a membrane roofing specialist. The gutter is corroded in areas. This will lead to the inadequate discharge of rainwater. We recommend a roofing contractor conduct further investigation. Allow to constantly monitor and maintain as required.

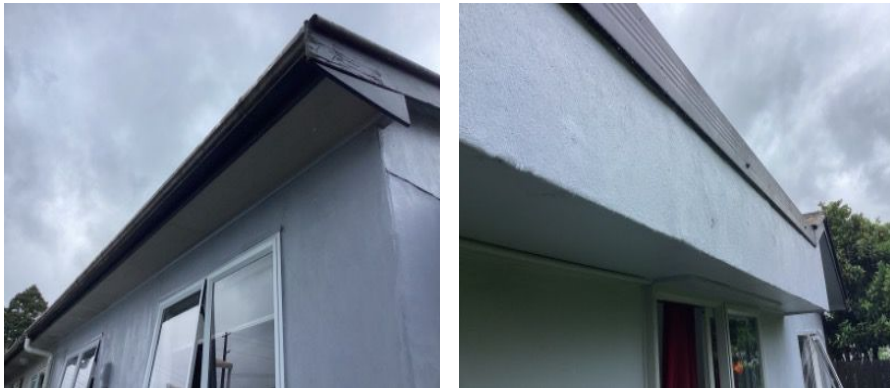
Wet rot decay is present in timber fascia. The fascia is damaged. We recommend this is replaced. Some of the soffits are cracked.

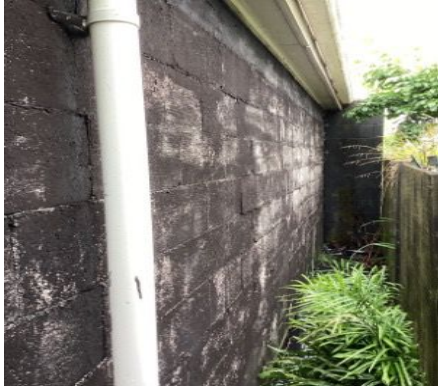
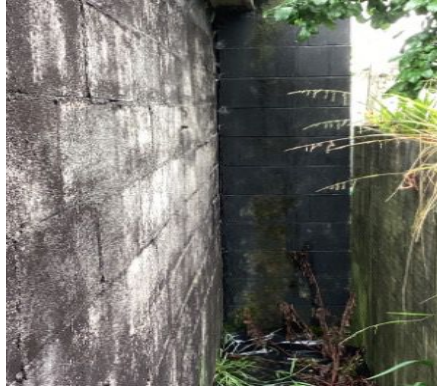
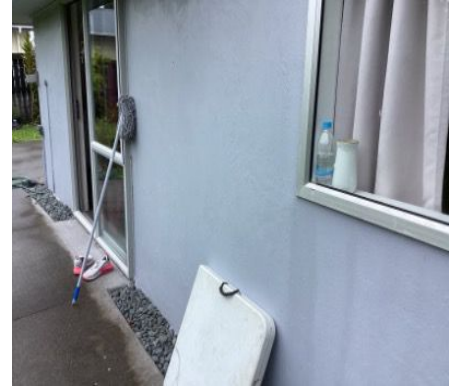
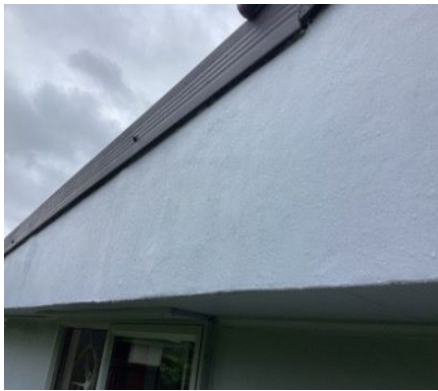
Plastered render over a backing substrate relies on a coating to resist the penetration of moisture. This system is therefore of high concern. Systems such as the one on this dwelling have the potential to allow water entry and deterioration through poor application and installation, lack of maintenance, poor detailing and complexity. Plastered systems similar to the cladding on this dwelling can allow water entry through cracks and complex junctions. From our visual inspection, the cladding appears to be performing; however, we recommend the cladding should be inspected semi-annually (ideally at the end of winter and end of summer) - any cracking or deterioration of the cladding should be investigated by a suitably qualified cladding specialist.

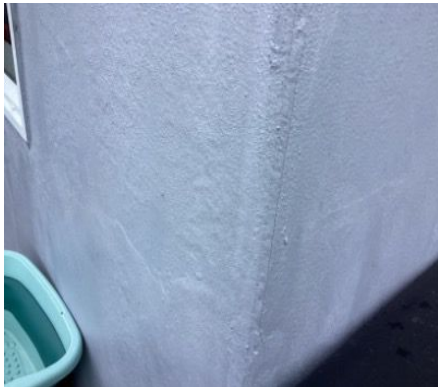
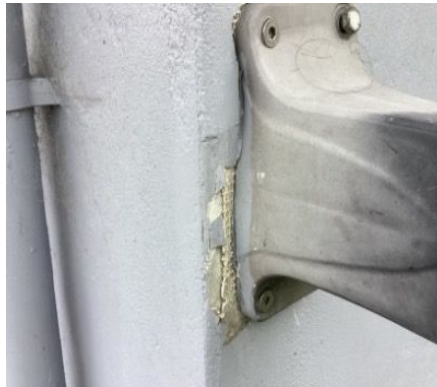
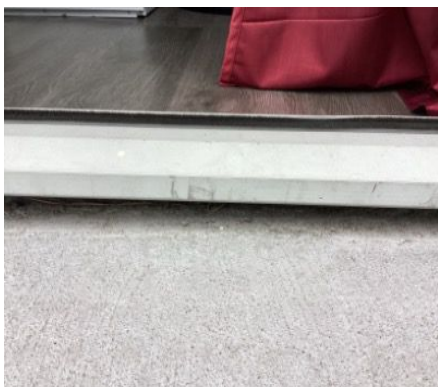
Blocks not sealed correctly.  
Recommend to repair and seal.

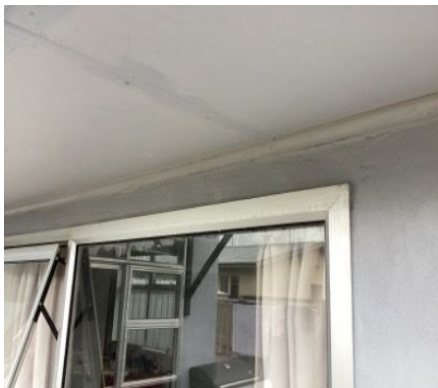
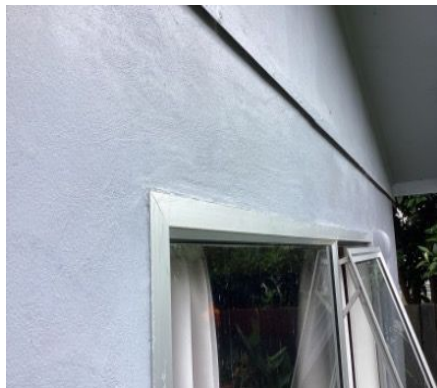
No head flashing over joinery. This may affect the weather tightness of the junction.

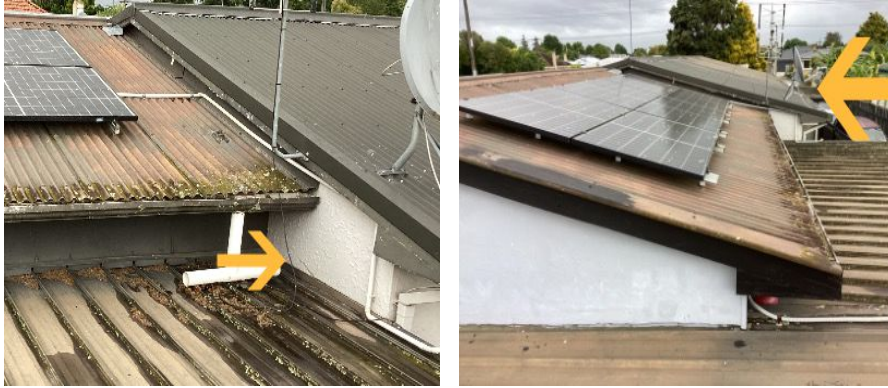
House next door

The house is adjoining the house next door, please check council records for details and sign off for fire wall.

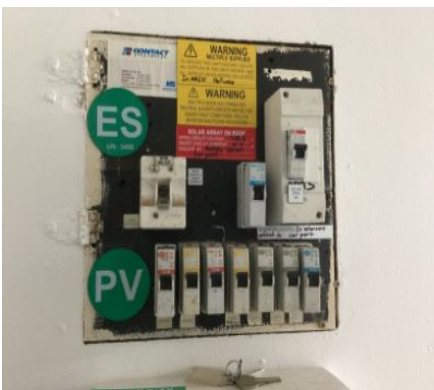
There is no cover over the electrical circuits. We recommend this is installed.

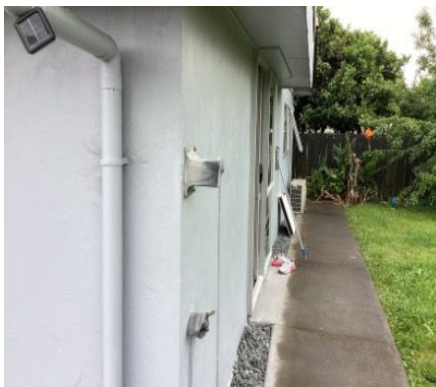
Direct fixed.

G

The cladding on this dwelling is direct fixed. This places the dwelling in a higher risk concern level. Direct fixed claddings rely solely on the cladding to keep the house weather tight. As a result the cladding, penetrations and complex junctions should be checked annually and any cracks or deterioration of the surface coating or sealing remedied. Allow to constantly monitor and maintain as required.

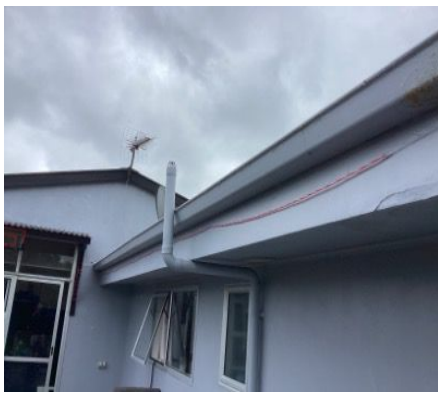
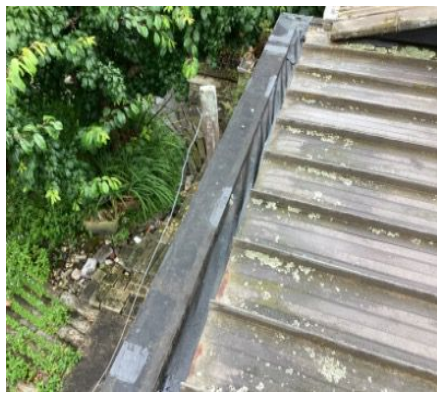
Exterior mounted gutters. Internal gutters.

O

There are internal gutters installed. The membrane gutter coatings such as the one on this dwelling have the potential to allow water entry through poor application and installation, lack of maintenance, poor detailing and complex junctions. This tends to occur particularly on buildings built between 1990 and 2006. We suggest that a thorough examination is completed bi-annually (ideally at the end of winter and end of summer), and any bubbling, water pooling, lifting of membrane or any signs of deterioration of the membrane should be investigated by a membrane roofing specialist. We recommend the membrane be investigated by a membrane roofing specialist.

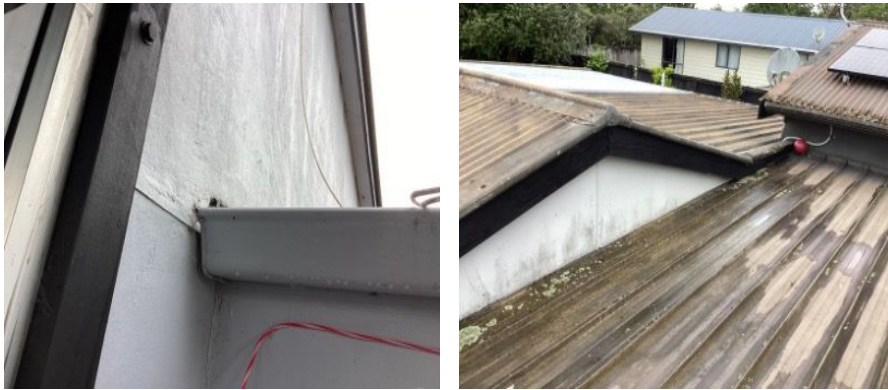
Cladding to ground junction. Gutter to wall junction. Wall to roof.

There are high risk junctions installed that has raised concern to the inspector. Please see photo's. The high risk junction such as the one on this dwelling has the potential to allow water entry and deterioration through poor application and installation, lack of maintenance, poor detailing and complexity. This tends to occur particularly on buildings built between 1990 and 2006. We suggest that a thorough examination is completed bi-annually (ideally at the end of winter and end of summer), and any sealant breakdown, water pooling or any signs of deterioration of the junction should be investigated by a weather tightness specialist. On the balance of probability it is likely that this junction will leak if it is not detailed more effectively. We recommend this junction be further investigated by a weather tightness specialist.

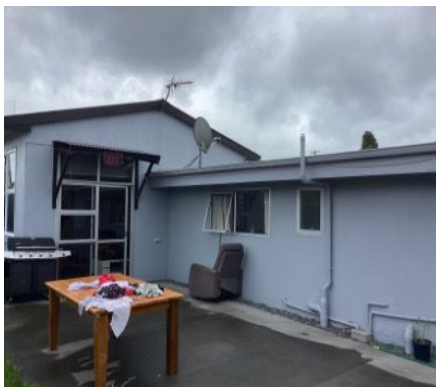
1950's

G

Older houses need more maintenance and have an increased cost to keep them in a reasonable condition. We suggest that a thorough examination is completed bi-annually (ideally at the end of winter and end of summer), and any rot, cracking, paint flaking, or any signs of deterioration of the exterior envelope should be investigated by a specialist. On the balance of probability it is likely that this exterior envelop will need a large sum of money spent on it in the very near future. We recommend this dwelling be further investigated by a licensed builder to quote for the up and coming repairs. No visible issues at time of the inspection. Allow to constantly monitor and maintain as required.

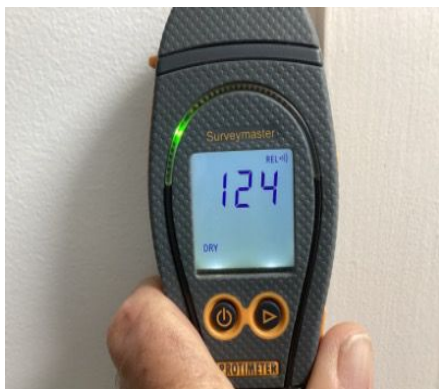
Hall

G

No visible issues noted during the inspection.

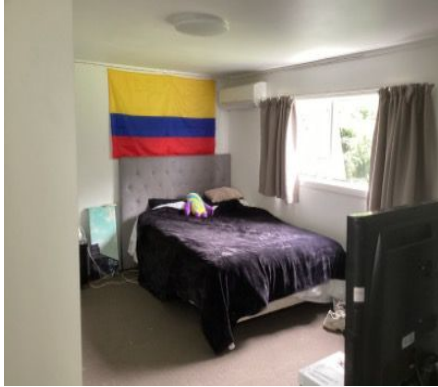
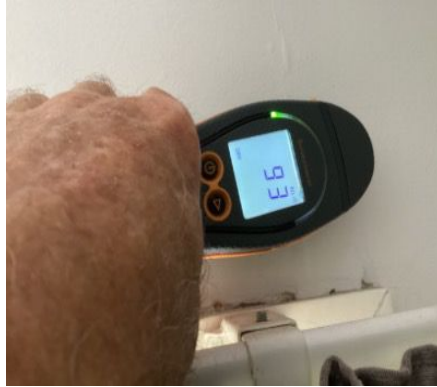
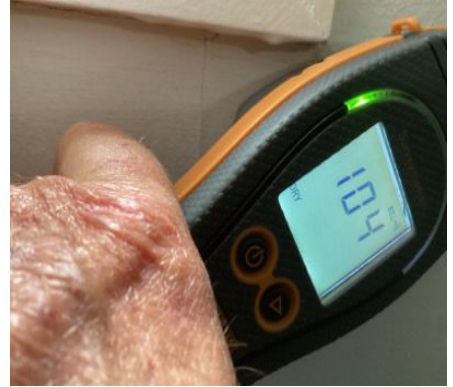
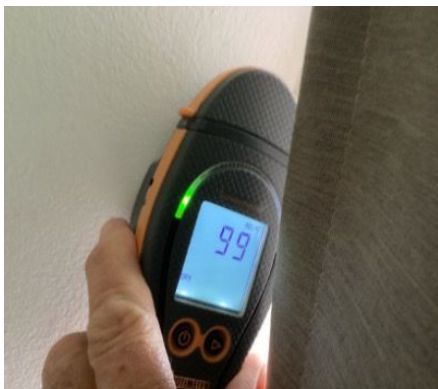
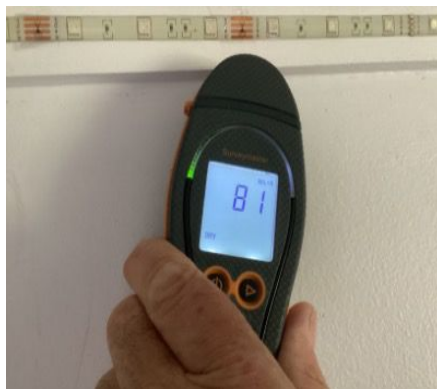
Bedroom one

G

No visible issues noted during the inspection.

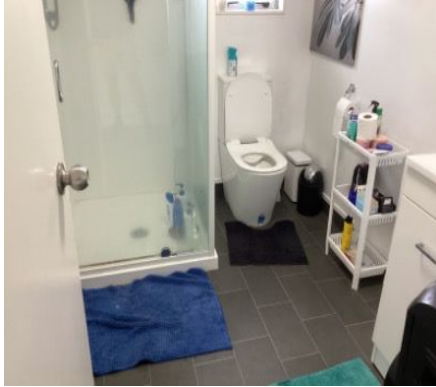
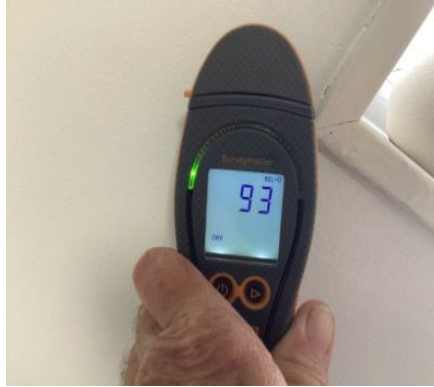
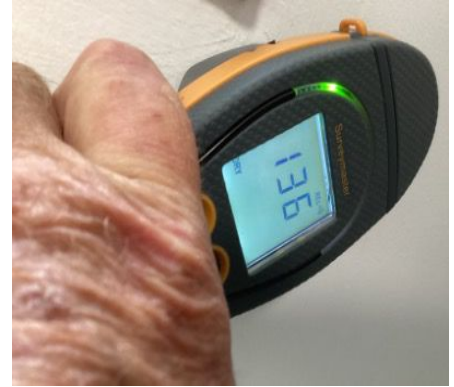
Bathroom one

G

No visible issues noted during the inspection.

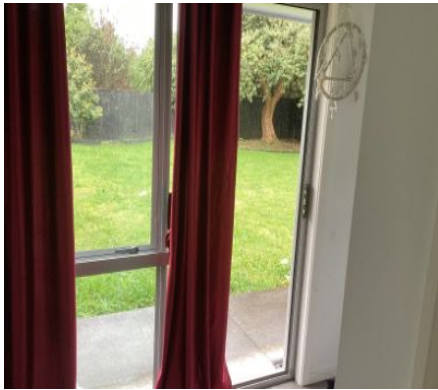
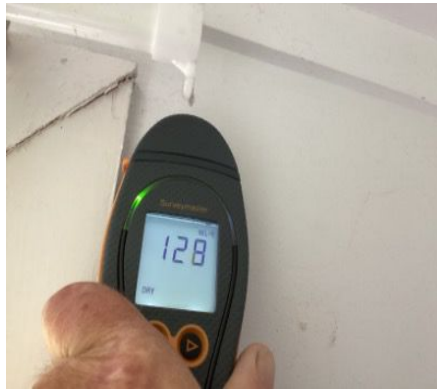
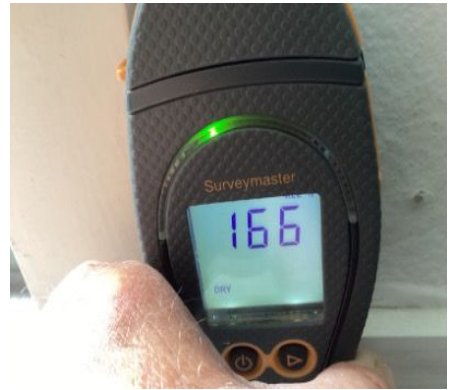
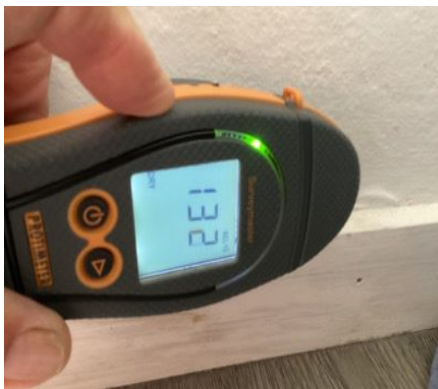
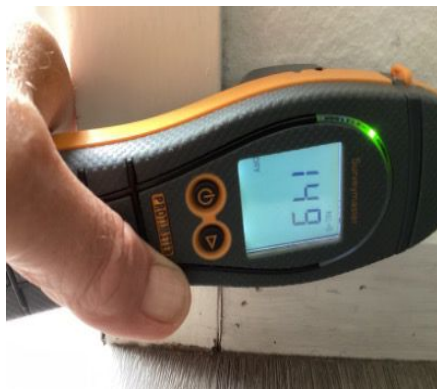
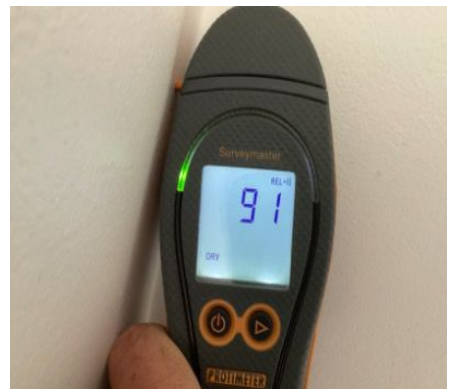
Laundry

G

No visible issues noted during the inspection.

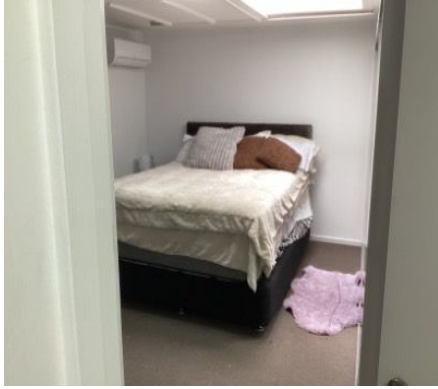
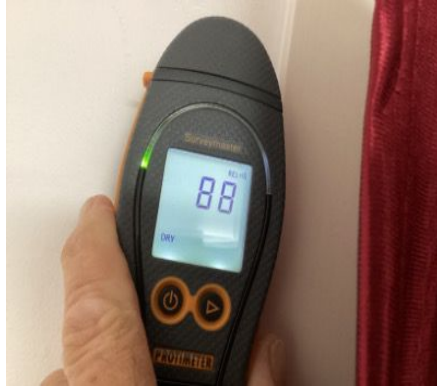
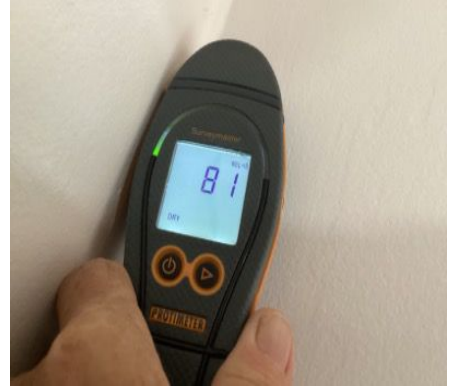
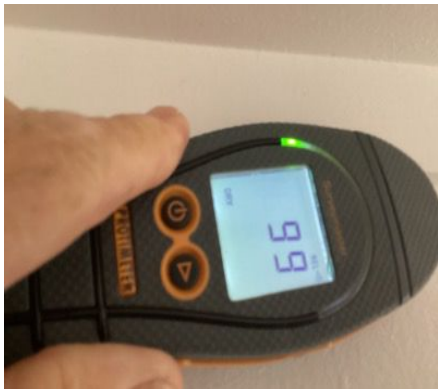
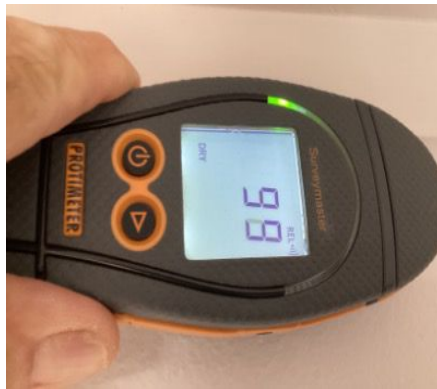
Bedroom two

G

No visible issues noted during the inspection.

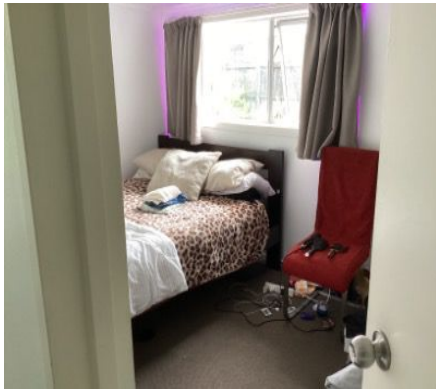
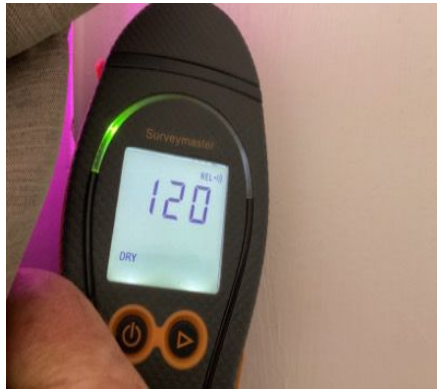
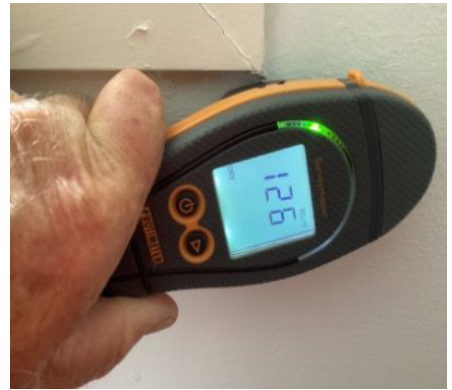
Bedroom three

G

No visible issues noted during the inspection.

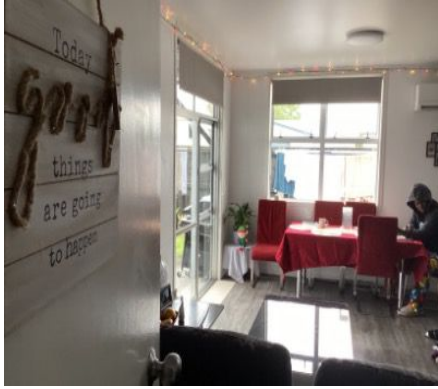
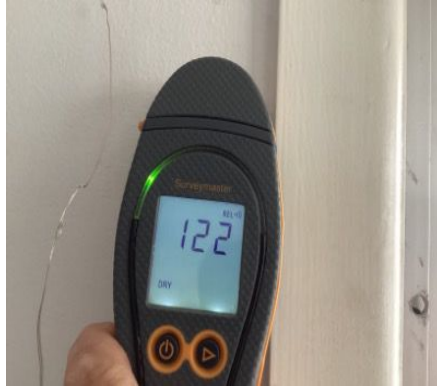
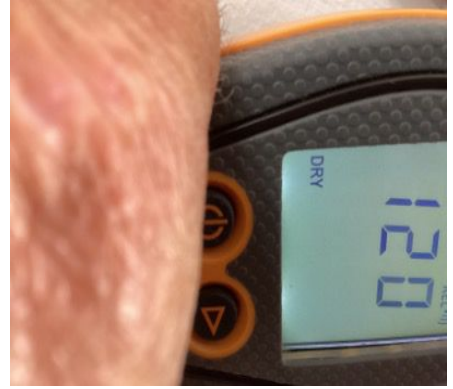
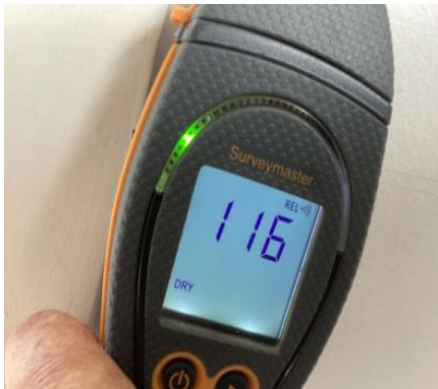
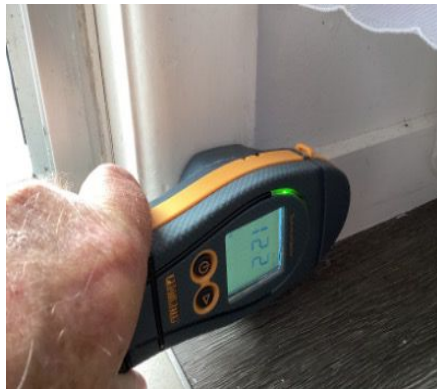
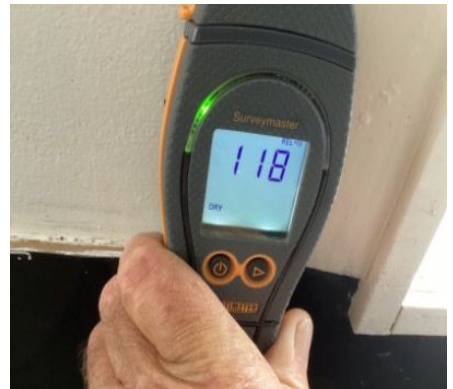
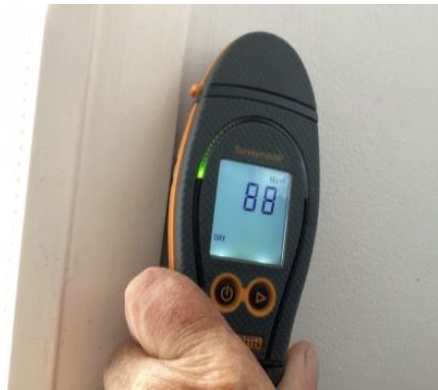
Dining room Kitchen Lounge

G

No visible issues noted during the inspection.

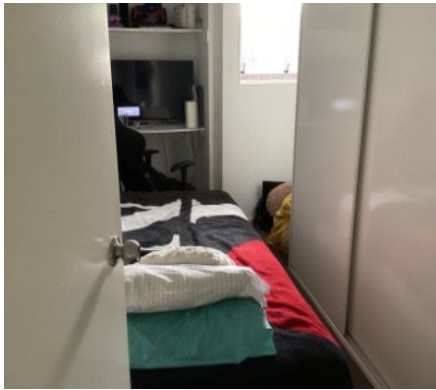
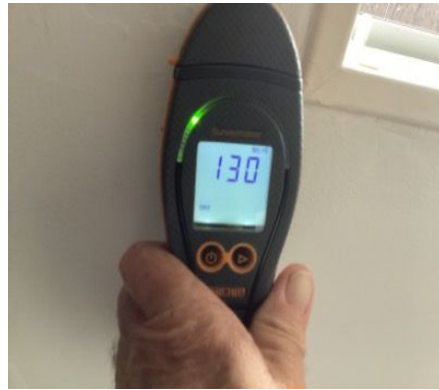
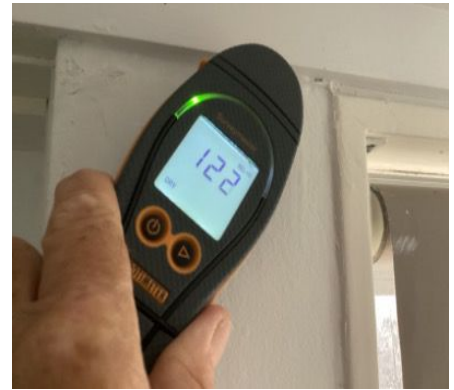
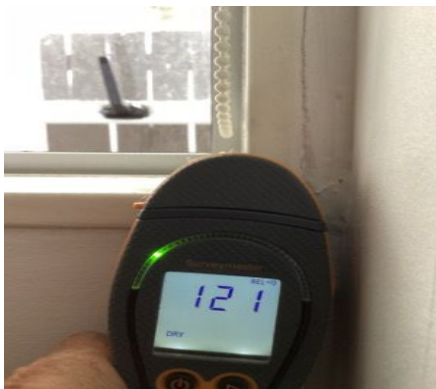
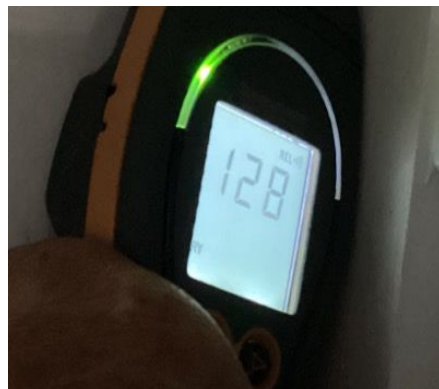
Bedroom four

**G**

No visible issues noted during the inspection.

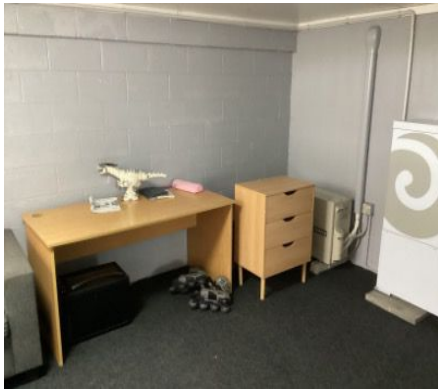
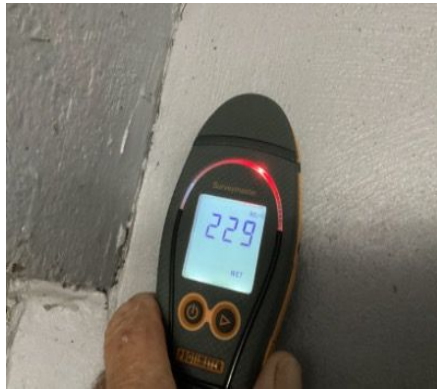
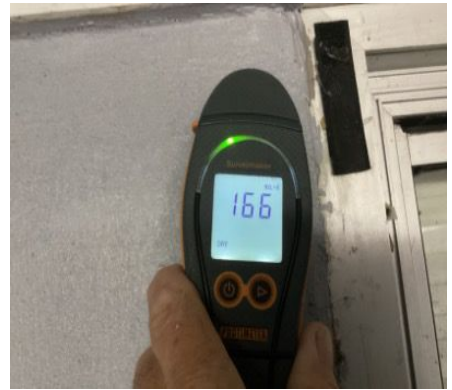
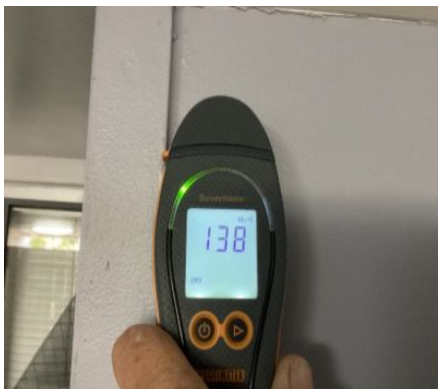
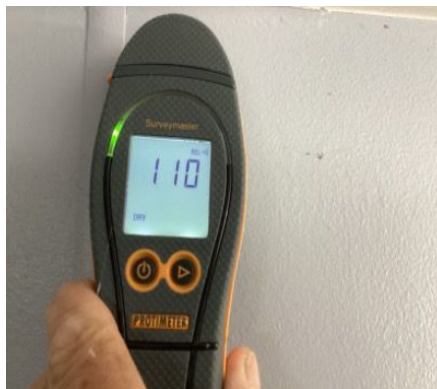
Garage

A higher than average moisture reading was noted. On the balance of probability it is likely that this high reading is caused by a weather tightness issue. We recommend further investigation by a thermographer or weather tightness specialist.

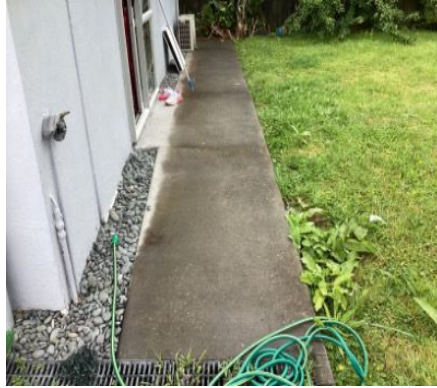
Part of the driveway is shared; we recommend you further investigate with your lawyer's assistance what obligations you have in regard to repairs and maintenance of the shared driveway. The surface of the driveway requires repair. There is subsidence to the driveway. Allow to constantly monitor and maintain as required.

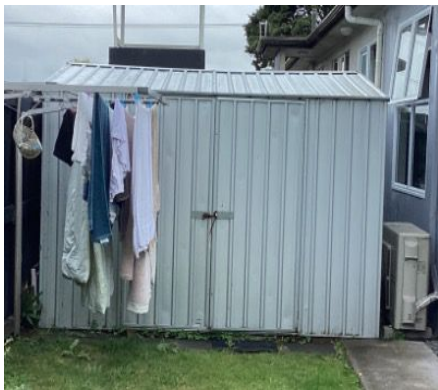
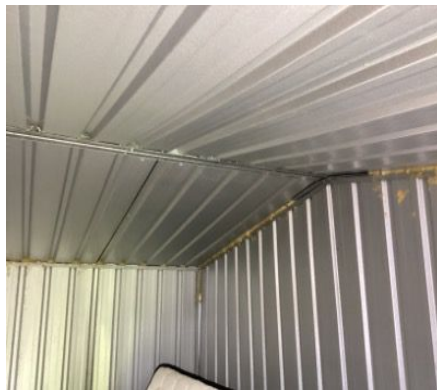
Garden shed.

There is minor decay/weathering to the outbuilding structure.

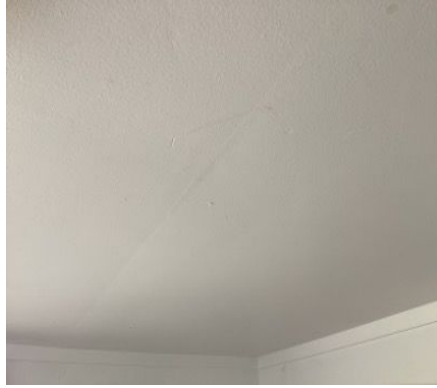
The ceiling linings have minor imperfections. These appear to be aesthetic. The ceiling height is low. There are nails "popping" in areas. We recommend these are repaired when the affected area is next redecorated.

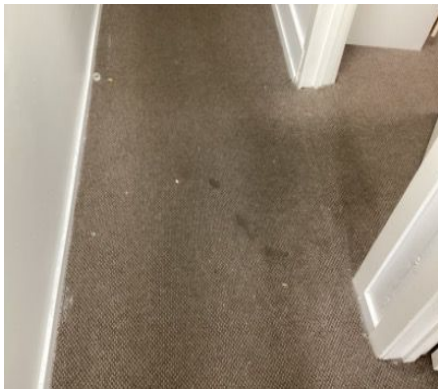
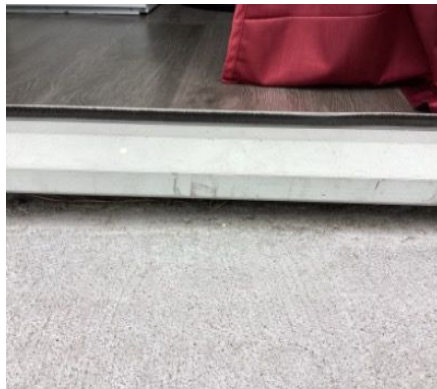
Gaps in the finish

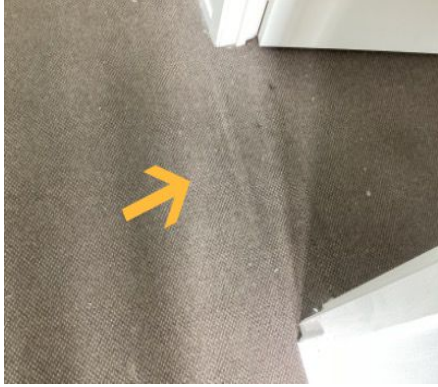
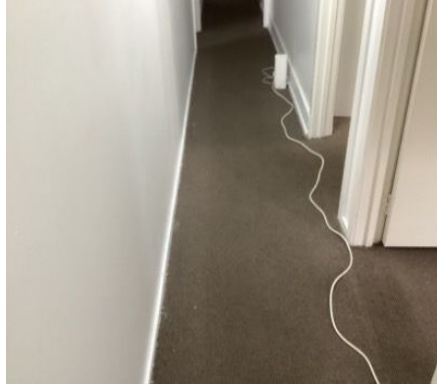
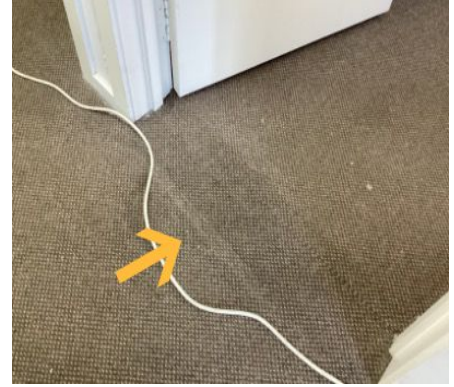
The floor is uneven in places.

Step up into bedrooms

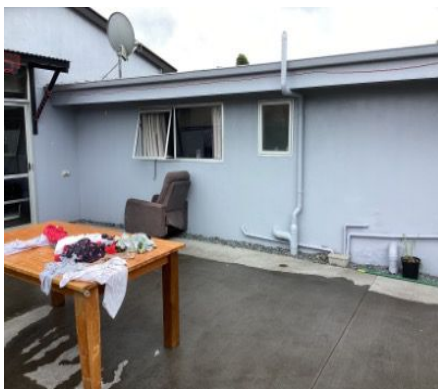
Room addition.

This room appears to be an addition. It is recommended that Council records be checked to confirm that all relevant Consents were applied for and signed off Local Authority. As noted above.

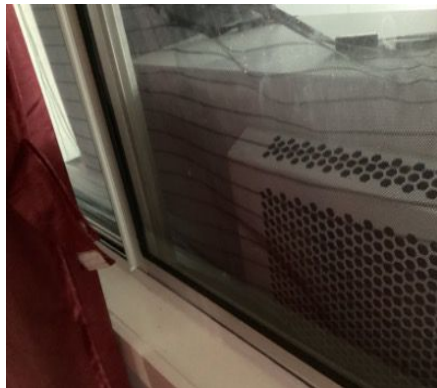
There is skylights located in the ceiling. Skylights are high maintenance windows that are very hard to flash on the roof side and are prone to leaking. Allow to monitor the surrounding ceiling linings. If the paint begins to bubble, blister or peel call a qualified builder as these are tell tail signs of leaking. Some maintenance is required to joinery hardware. Weathered glazing beads beginning to shrink which may allow water ingress. We recommend further investigation.
